No. 284

CORROSION EMBRITTLEMENT OF DURALUMIN

III. EFFECT OF THE PREVIOUS TREATMENT OF SHEET MATERIAL  
ON THE SUSCEPTIBILITY TO THIS TYPE OF CORROSION

By Henry S. Rawdon  
Bureau of Standards

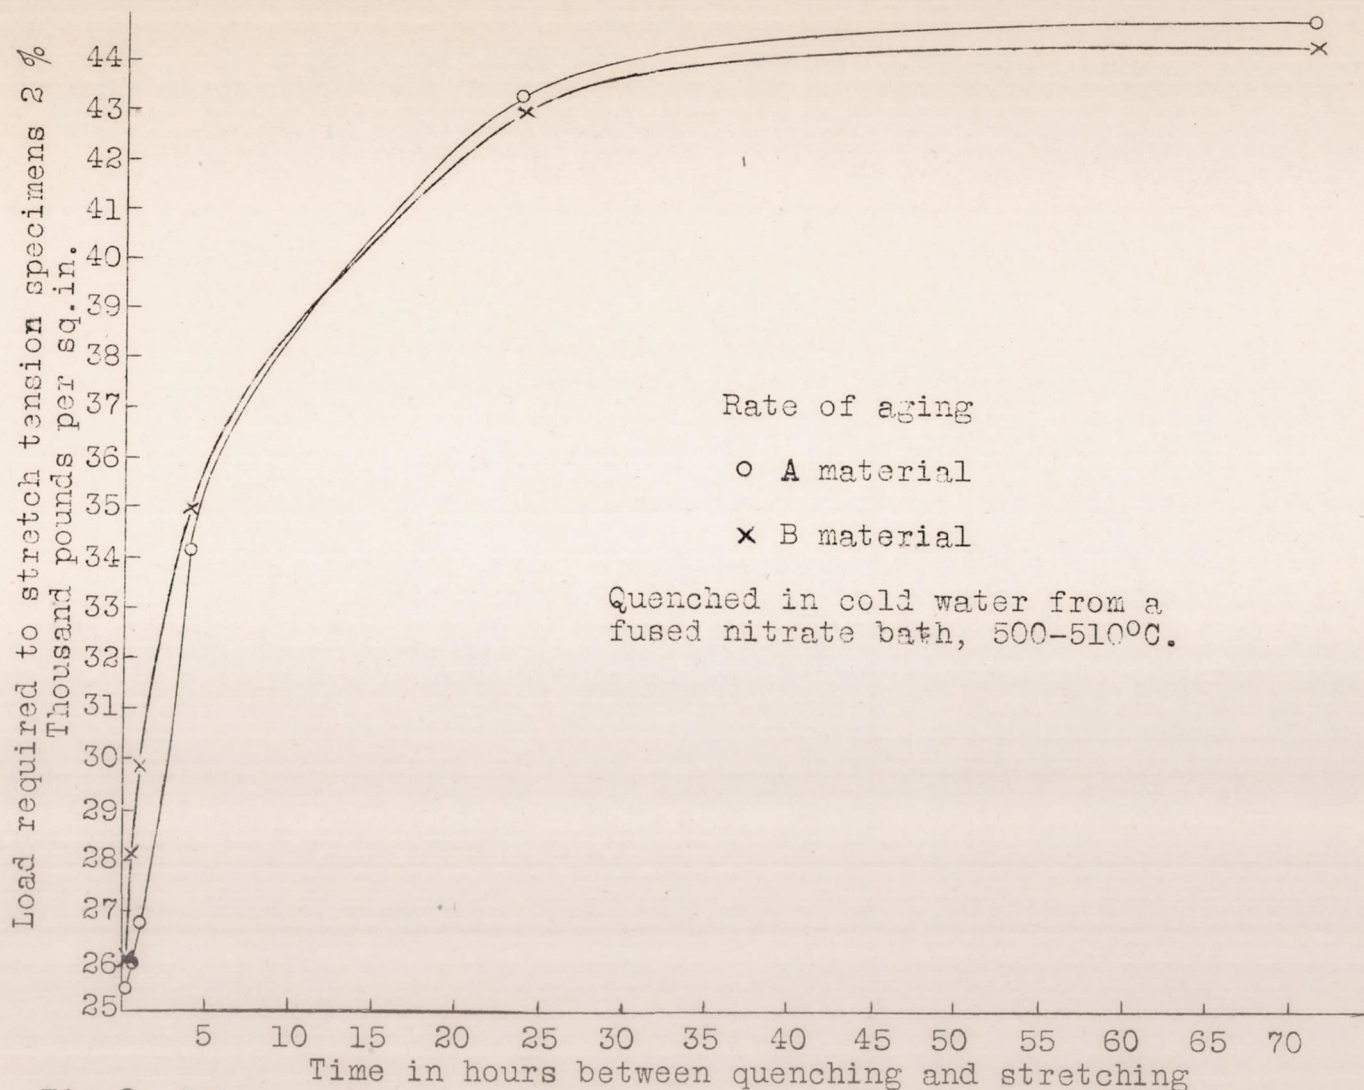
The results obtained with tension bars which were stretched a definite amount within a known period after being quenched serve to confirm this conclusion. The aging process by which duralumin becomes stronger and harder begins very shortly after the material has been quenched and continues at a slowly diminishing rate for several days. Approximately full strength is attained after 72 hours' aging. This is shown by Figure 2, which gives the stress required in order to stretch a specimen 2 per cent in length. Such a diagram demonstrates more strikingly the advantage of carrying out all forming operations immediately after quenching than does the one usually given which shows the change in hardness occurring during aging. As will be seen from the results of Figure 3, permanent stretching of sheet duralumin by an amount of 2 per cent (measured on a central 2-inch gauge length), does not appreciably affect the corrosion behavior of the material, provided that the stretching is done within 24 hours after the material has been quenched. Bars stretched 72 hours after being quenched gave indications of a somewhat greater susceptibility to corrosion. Even in these cases, however, the results, for the corrosive condition used, were not at all suggestive that the corrosive attack had been very greatly accelerated by deforming the sheet in this manner.

Fig.2 Aging curve of quenched duralumin. The load required to stretch the material 2 per cent in 2 inches has been used as a measure of the aging effect.

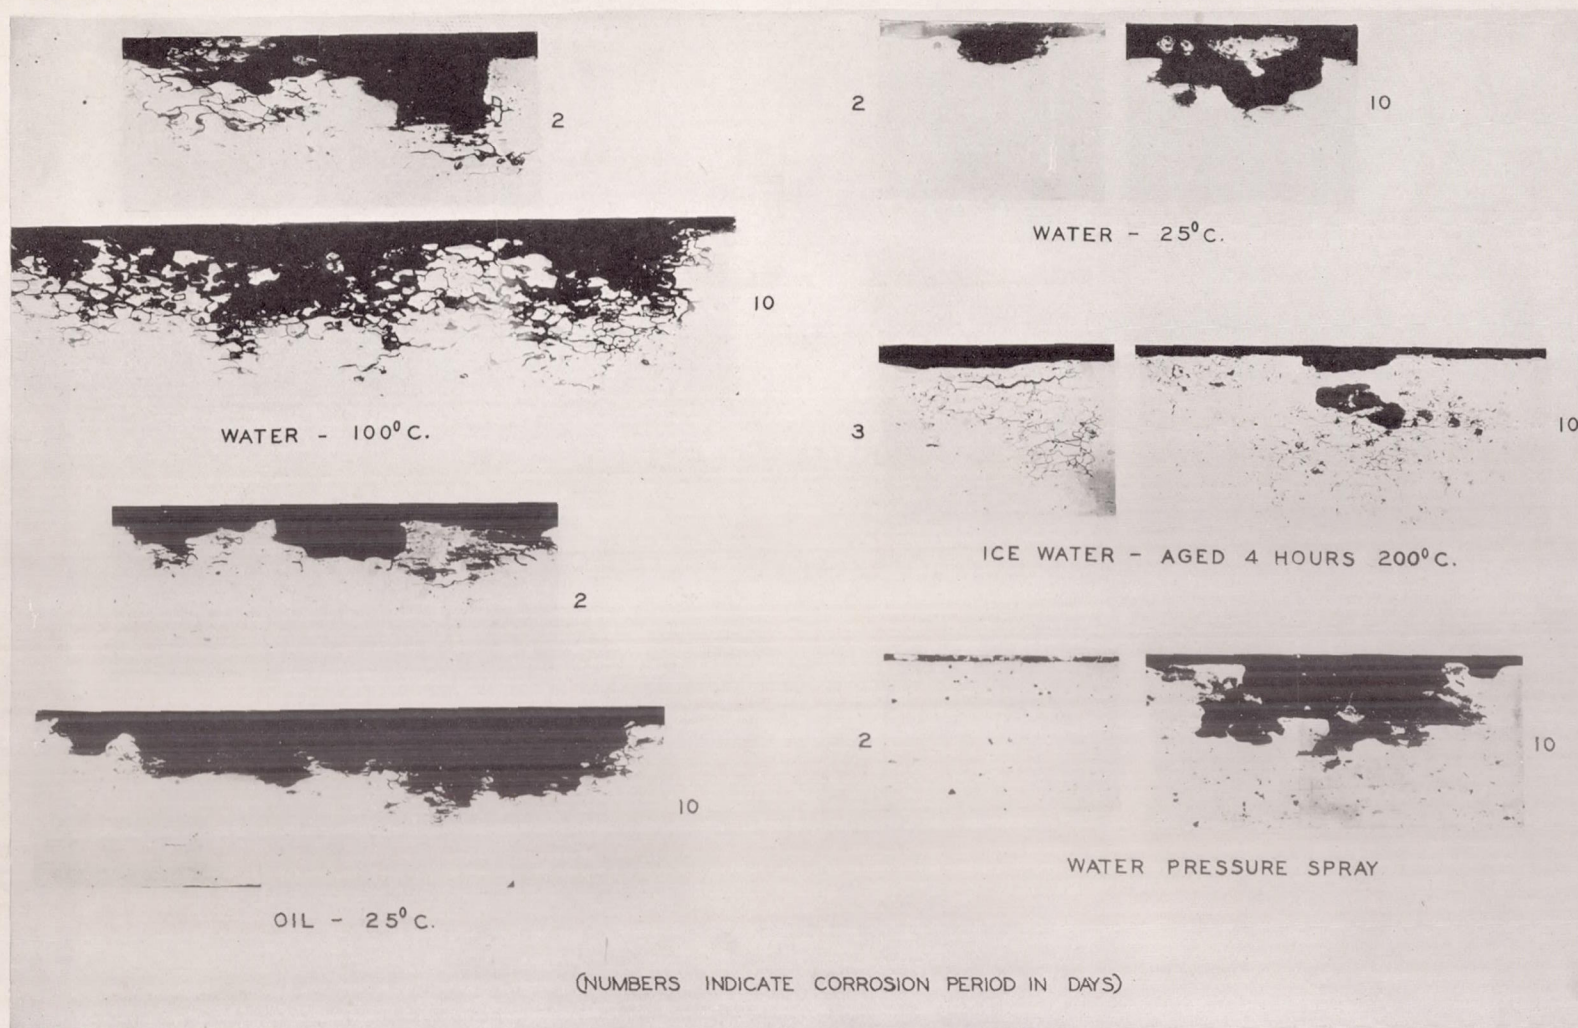
Duralumin tension specimens which had been heat-treated by being permitted to age 6 days at room temperature after being quenched in various ways were corroded by the intermittent immersion method previously described. The following quenching methods were used: boiling water; oil (Houghton's No. 2) at 29°C (84°F); water, 25°C (77°F); 15 per cent sodium chloride brine, 27°C (80°F); ice water, 2°C (35°F); and a water "pressure spray" (50 lb. pressure from a series of orifices surrounding the specimen). (The sodium-chloride brine was used only for experimental purposes, because of its high "quenching properties" as shown with steel, and is not recommended as a commercial method for aluminum alloys.) The properties of the specimens after corrosion are summarized in Figure 5. The greater susceptibility to corrosion of the material quenched in hot water or in oil is very evident, in the change in both the tensile strength and in the elongation. The differences in properties, after corrosion, of the specimens quenched in water at room temperature as compared with those quenched more drastically are, on the whole, not pronounced enough to warrant a recommendation for the exclusive use of the one in preference to the other. The microstructure of the corroded specimens clearly shows, even more strikingly than do the tension tests, the difference in the nature of the corrosive attack following the different quenching treatments. This is shown in Figure 6.

Fig. 6 Microstructure of corroded sheet duralumin supplementing Figure 5

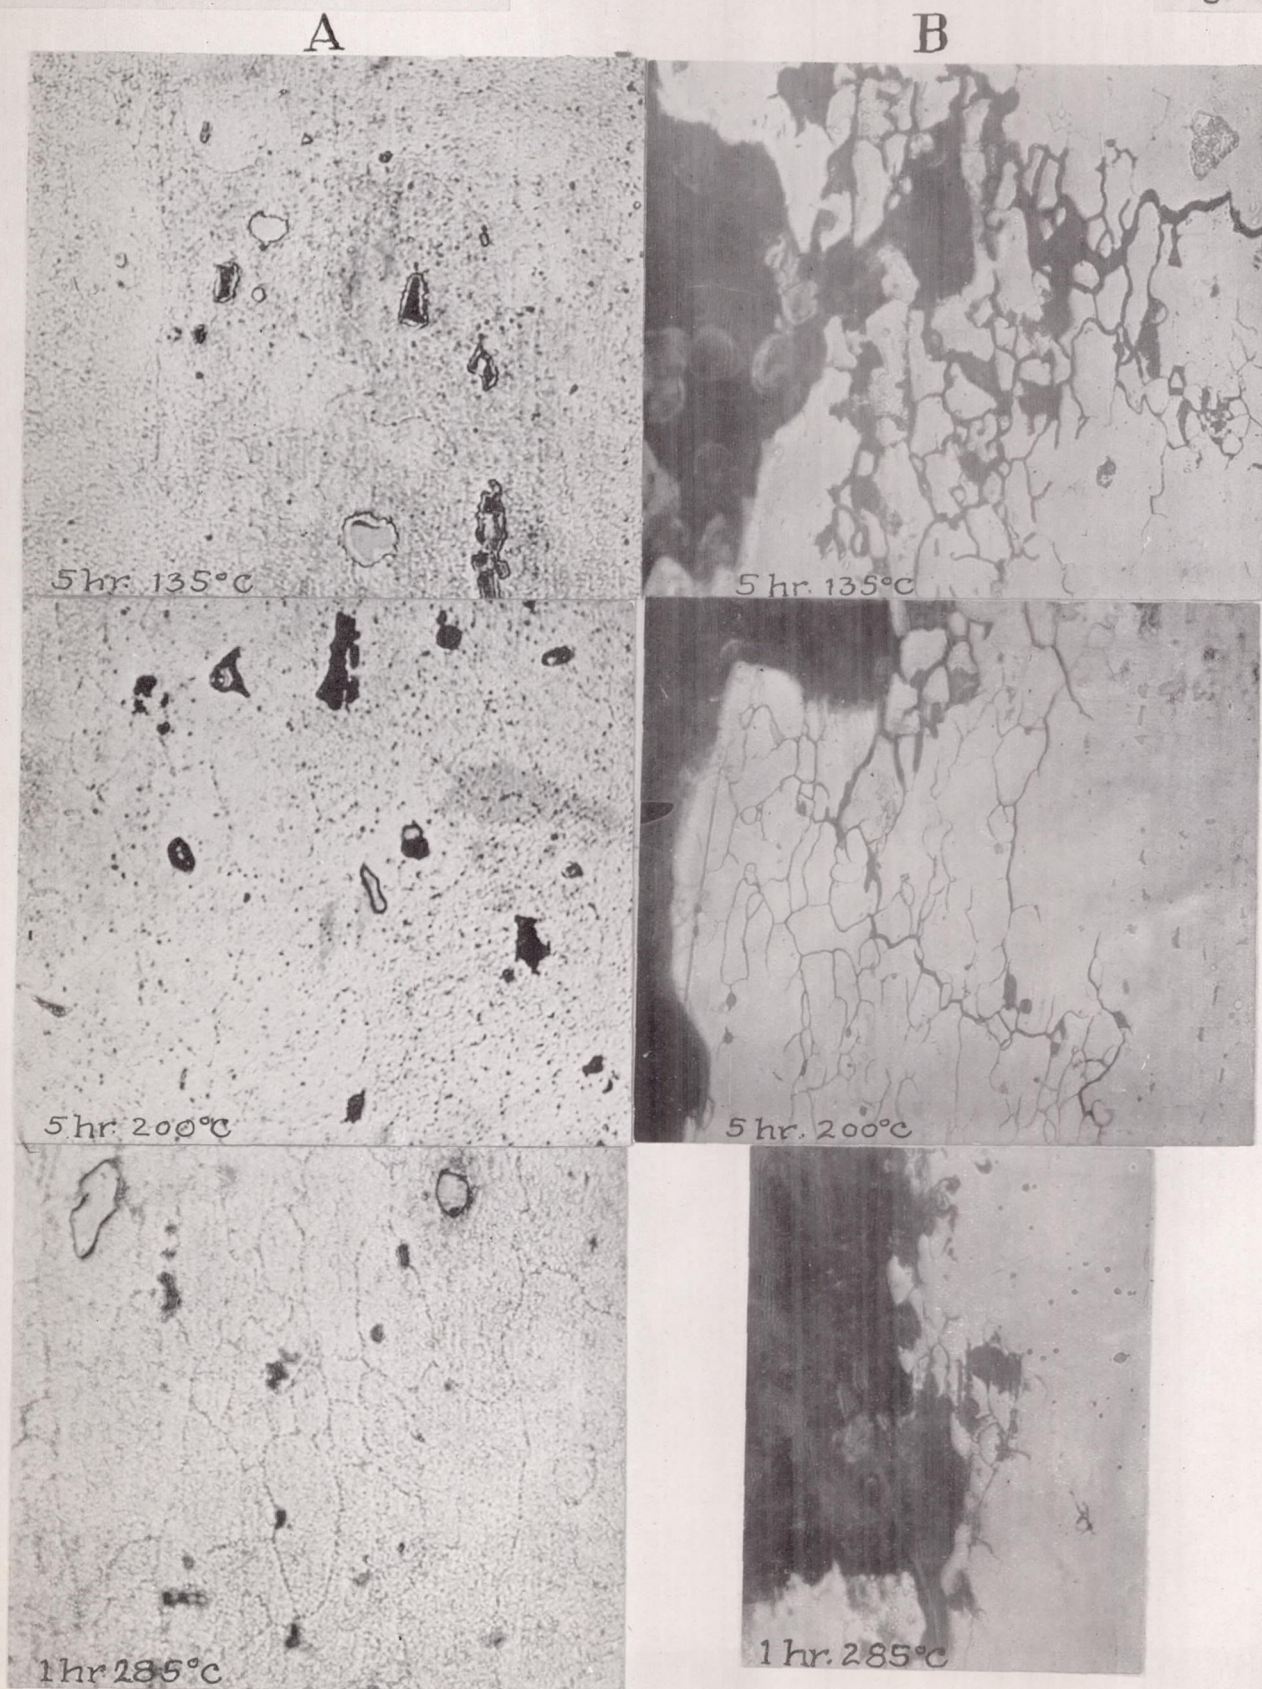
the three temperatures used, 135°C, 200°C, and 285°C, the intercrystalline attack was most pronounced in the material heated at 135°C (Fig. 9). The intercrystalline attack decreased as the reheating temperature was raised above 135°C, the intercrystalline corrosive attack of the material heated at 285°C being relatively slight, although the pitting was quite pronounced.

Fig. 9 Microstructure of corroded sheet duralumin, supplementing Figure 8. A, x 1000; B, x 250. Heated after aging as indicated.

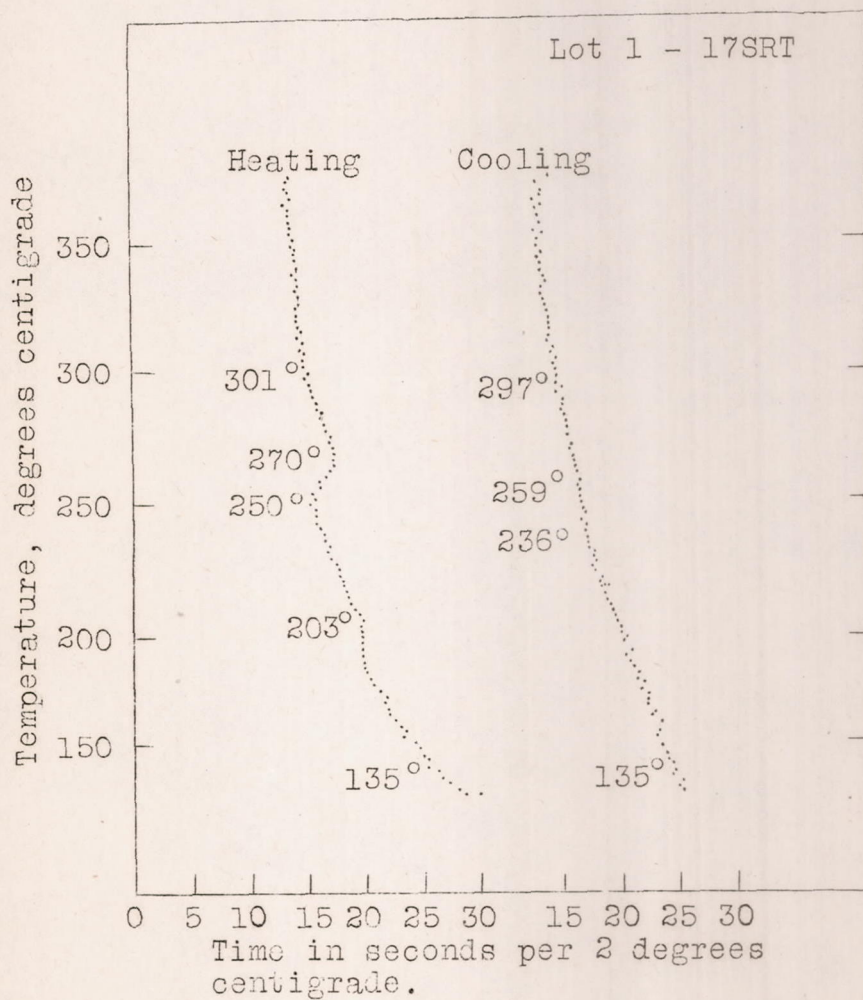
prolonging the accelerated aging treatment or by reheating the alloy after it has been aged at room temperature. By such a treatment the particles of the hardening constituents become large enough to be seen with the microscope. In Figure 10 are given thermal analysis curves (inverse-rate method) of a sample of commercial heat-treated duralumin sheet. It will be seen that two heat evolutions are shown by the heating curve, at 200°C and 270°C approximately, the exact nature of which is still in question but which are undoubtedly related to the age-hardening process. The cooling curve indicates nothing unusual in the behavior of the alloy. The micrographs of Figure 9 show the structural appearance of duralumin heated, after aging, at temperatures of 135, 200 and 285°C, respectively, these temperatures being chosen by reference to the heating curve, together with the structure of the material after accelerated corrosion in the laboratory. It will be seen from these micrographs that, as the material was heated, the aluminum-rich matrix changed in character by the appearance of small particles of the hardening constituents disseminated throughout it. This appearance became more pronounced as the heating was continued and the tendency toward localization of the particles on the grain boundaries became more marked. This preferential coalescence of the particles on the grain boundaries, is most probably to be associated with the intercrystalline form of corrosion which occurs in this material. However, it is evident that the relation between these

two phenomena is not a simple one, since the tendency to intercrystalline corrosion was found to be most marked in specimens heated at  $135^{\circ}\text{C}$  in which material the grain boundary pattern was extremely slight whereas specimens ( $285^{\circ}\text{C}$ ) in which this pattern was most markedly developed showed a much less pronounced tendency toward an intercrystalline attack.

Fig.10 Thermal analysis curves of duralumin.
